**TOPICAL REPORT
CSTC TOPIC 2004-E
CHEMICAL EXPOSURES DURING CLOSURE ACTIVITIES**

Case Study: InstaCote™ Oversized Low-Level Waste (LLW) to Transport from Rocky Flats Environmental Technology Site to Disposal Facilities

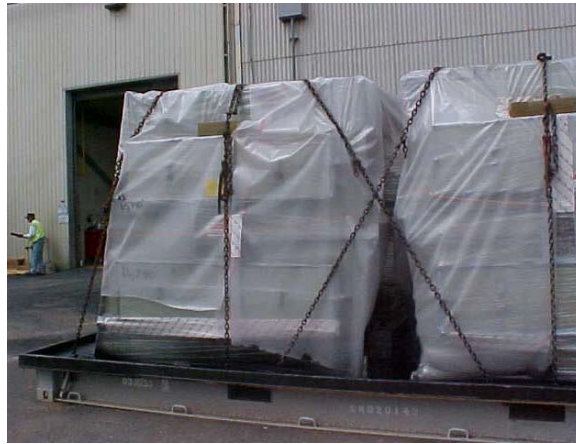
Fig. 1 - Furnaces prior to being covered with Dr. Shrink™ shrink wrap

Large pieces of low-level waste (LLW) are wrapped and InstaCote™ is applied to eliminate the need for size reduction of equipment and machinery at Rocky Flats during D&D operations. Size reduction creates many safety hazards that can be eliminated through this packaging technique.

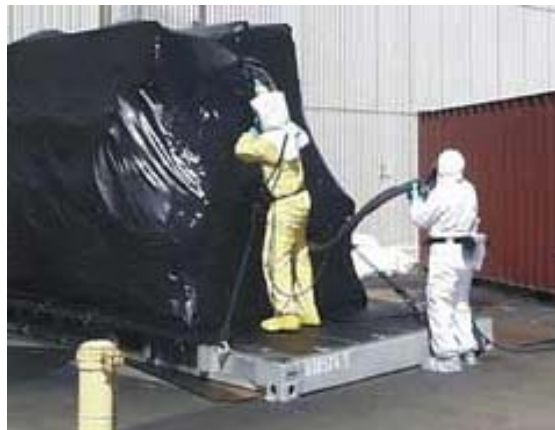
Fig. 2 - Furnaces after being covered with Dr. Shrink™ shrink wrap

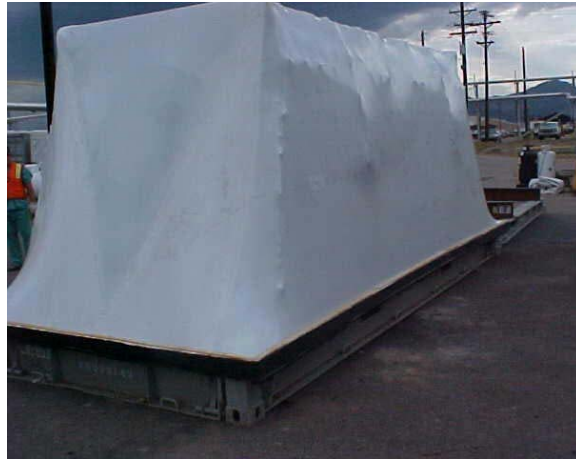
Fig. 3 - InstaCote™ being applied to furnaces

One component of InstaCote™ is methylene bisphenyl isocyanate (MDI). Occupational exposure to MDI can produce significant respiratory effects. Symptoms can include asthmatic breathing, retrosternal soreness, constriction of the chest, cough, retrobulbar pain, depression, headache, and insomnia. Because of the MDI, personal breathing zone samples were taken on employees who apply the coating. Sampling was conducted using a 37-mm cassette and sampling pump. The following chart compares the sampling results with the OSHA PEL and the ACGIH TLV.

InstaCote™ contains methylene bisphenyl isocyanate (MDI), which poses a hazard if not controlled and monitored. Workers in this activity should wear appropriate personal protective equipment (PPE), including supplied-air respirators, as needed based on the potential exposure of the employee. Industrial hygiene sampling should also be completed to determine job task exposure for each employee.
